Property Inspection Report

Dream Condo, Los Angeles, CA
Inspection prepared for: John Doe
Real Estate Agent: More Sales - Realtor

Date of Inspection: 10/25/2017

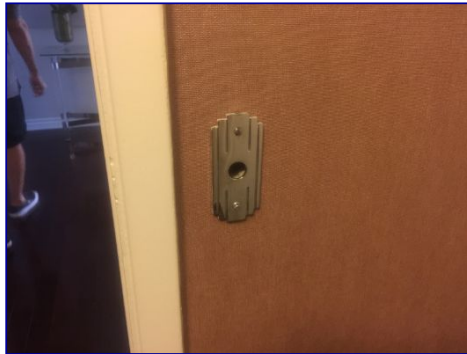
- **The doorbell did not operate when tested. Recommend checking the door bell button, chime & transformer & replace or repair as needed.**

The doorbell did not operate when tested. Recommend checking the door bell button, chime & transformer & replace or repair as needed.

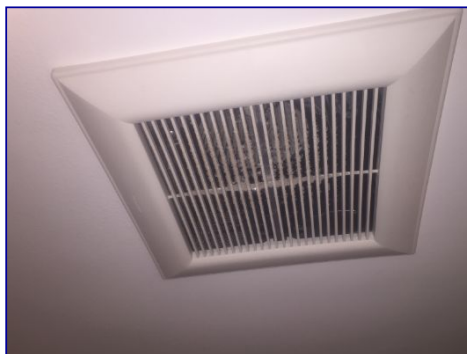
- **The Master bathroom exhaust fan was full of lint and did not function when tested.**

The Master bathroom exhaust fan was full of lint and did not function when tested.

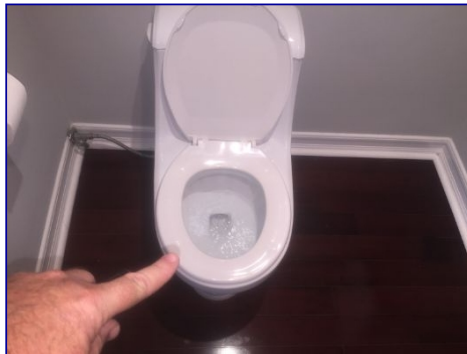
- **The front shared bathroom toilet did not function correctly.**

The front shared bathroom toilet did not function correctly.

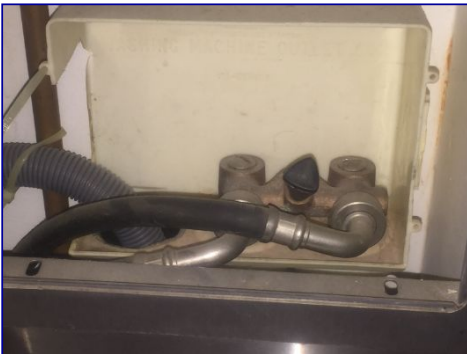
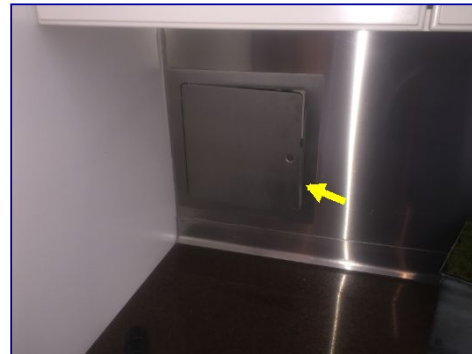
Access panel on kitchen sink houses the washing machine connections. Access panel on kitchen sink houses the washing machine connections.

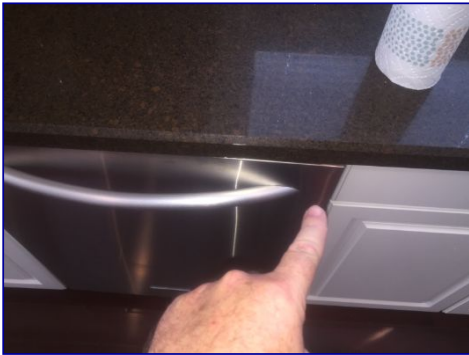
The dishwasher was not positioned properly. One side sticks out.

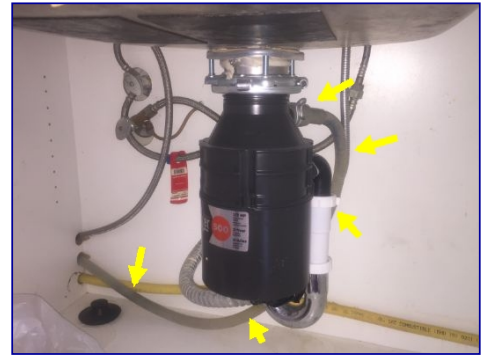
- The dishwasher was not positioned properly. One side sticks out.
- Dishwasher has no **air gap** installed on the drain line. In the event of a sewer backup this device prevents sewer matter from entering into dishwasher. Recommend having a qualified plumber install a air gap to prevent possible contamination.

Dishwasher has no air gap.

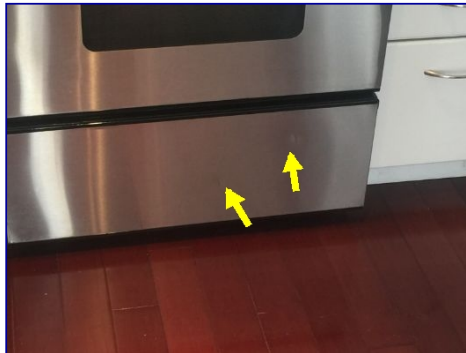
- The kitchen gas range has a few small dents on the lower drawer front.

The gas range has a few small dent on the lower drawer.

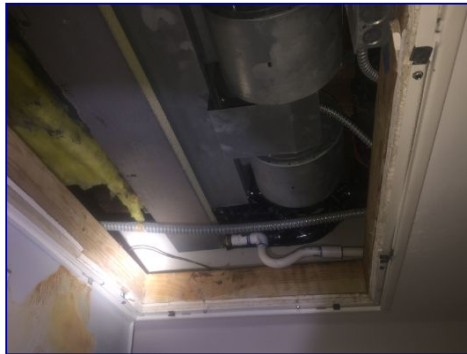
- There was no furnace enclosure. The furnace sat in an open area.

The furnace is located in a ceiling cabinet just inside the front door.

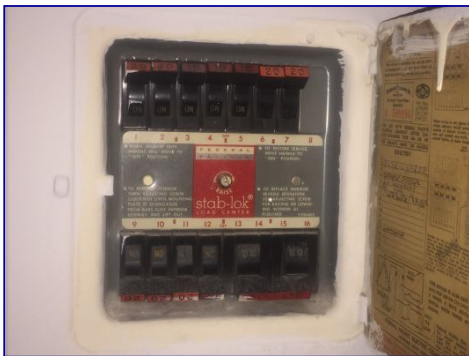
• **Concern:** There is a Federal Pacific Electric service panel in the house. There are studies that show that some FPE circuit breakers are prone to problems that can lead to failures, lack of proper protection of circuits and other serious issues, including fire and electrocution. Although the Consumer Products Safety Commission has not issued a formal product recall, the panel is old and the company is now out of business. We cannot definitively call this panel defective, but recommend, for your peace of mind, to consult a qualified electrical contractor to get their opinion on this matter. You can learn more about this issue at: <http://www.codecheck.com/pdf/electri...%20Nov2003.pdf>, www.inspect-ny.com/fpe/fpepanel.htm, and <http://www.inspect-ny.com/fpe/CPSCsummary.htm>.

The home's electrical sub panel is in the bedroom hallway.

Stab-Lok Electrical Panel.

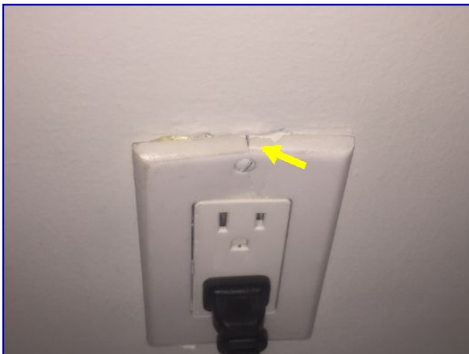
There was al broken cover plate for the electrical receptacles in the front bedrooms of the home.

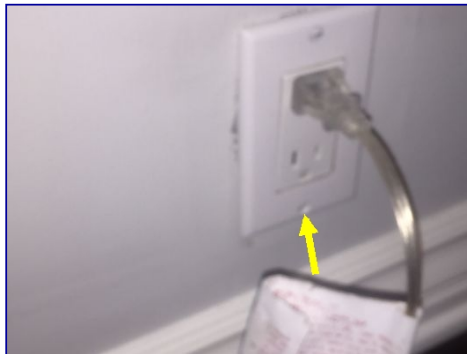
The electrical receptacle in the dining room back wall is missing a screw.

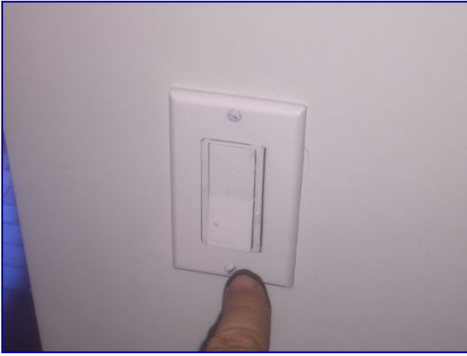
Dining room dimmer switch did not dim the light.

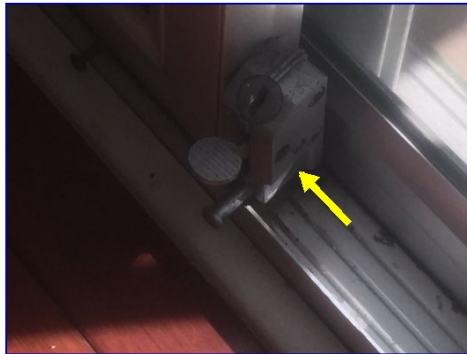
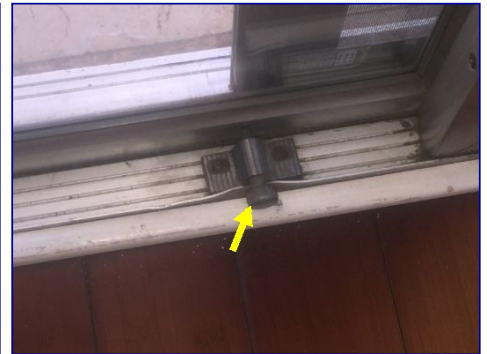
- Lower sliding glass door lock was missing a key, but the lock assembly is easily replaceable.
- Kitchen sliding glass door lower lock needs to be oiled.
- The living room sliding glass door is heavily scratched by a large pet.

The living room sliding glass door is heavily scratched by a large pet.

Lower sliding glass door lock was missing a key, but the lock assembly is easily replaceable.

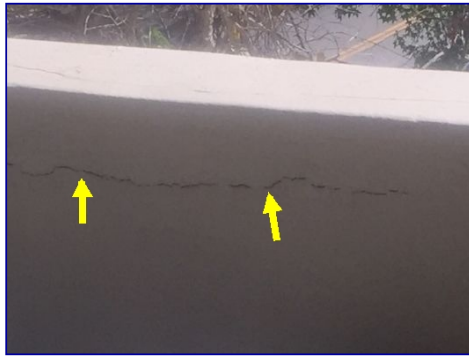
The back patio wall has a few small cracks in the drywall.

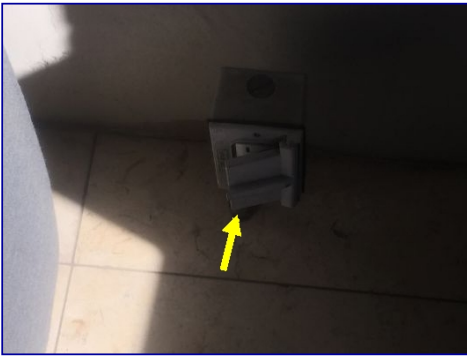
• The back patio GFCI receptacle had no power and needs a new cover. The receptacle needs to be repaired or replaced as needed.

The back patio GFCI receptacle had no power and needs a new cover.

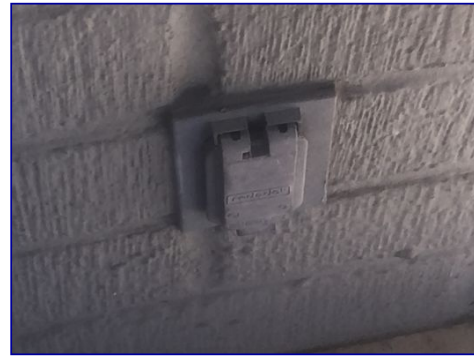
• Concern: The left side exterior electrical receptacle on the back patio was not GFCI protected.

The left side electrical receptacle on the back patio was not GFCI protected.

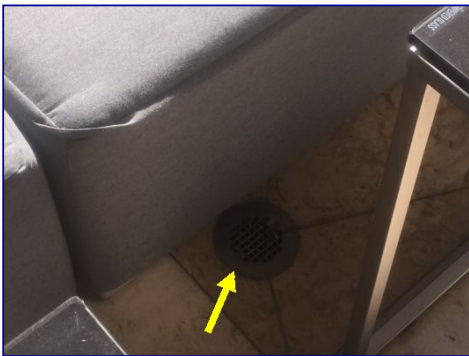
- The exterior patio floor drain drains to an exterior pipe, about four feet away. The pipe is open and birds may have nested inside. The pipe may need to be cleared of debris.
- Concern: The back patio tiled flooring is not slip resistant. The flooring may be a slip issue when wet.

Floor drain drains to the exterior wall.

This is the patio floor drain outlet. Birds may have nested inside.

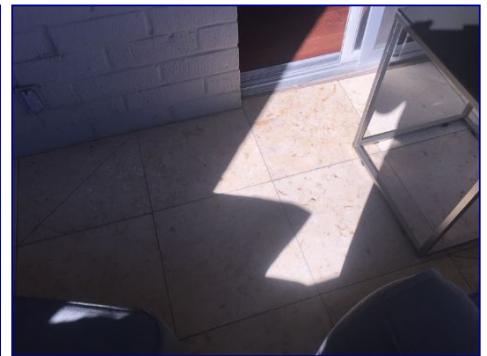
The back patio tiled flooring is not slip resistant. May have issues when wet.

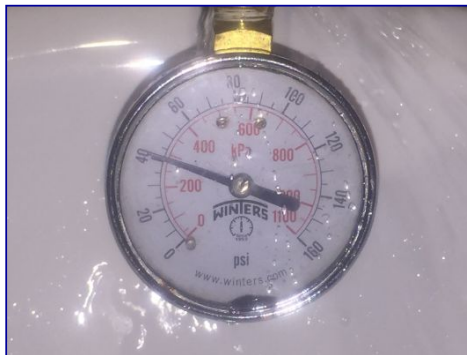
- The home's water pressure was tested at the water main on the front of the home and found to be 40 PSI at time of inspection.

The home's water pressure was 40 PSI.
